**OBERDORFER**<sup>®</sup>

# N26HDE Series Bronze Pedestal Rotary Gear Pumps

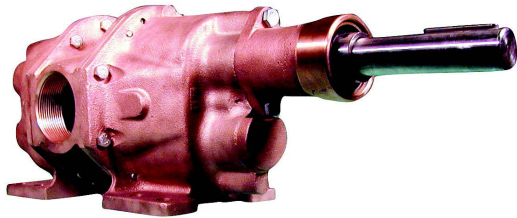
- All Bronze Castings and Stainless Steel Shafts
- Sealing Arrangement Interchangeable in Field with Proper Kit
- Outboard Ball Bearing Support for Belt Drive Applications
- Self Lubricating Carbon Bearings
- 2" BSPT Ports

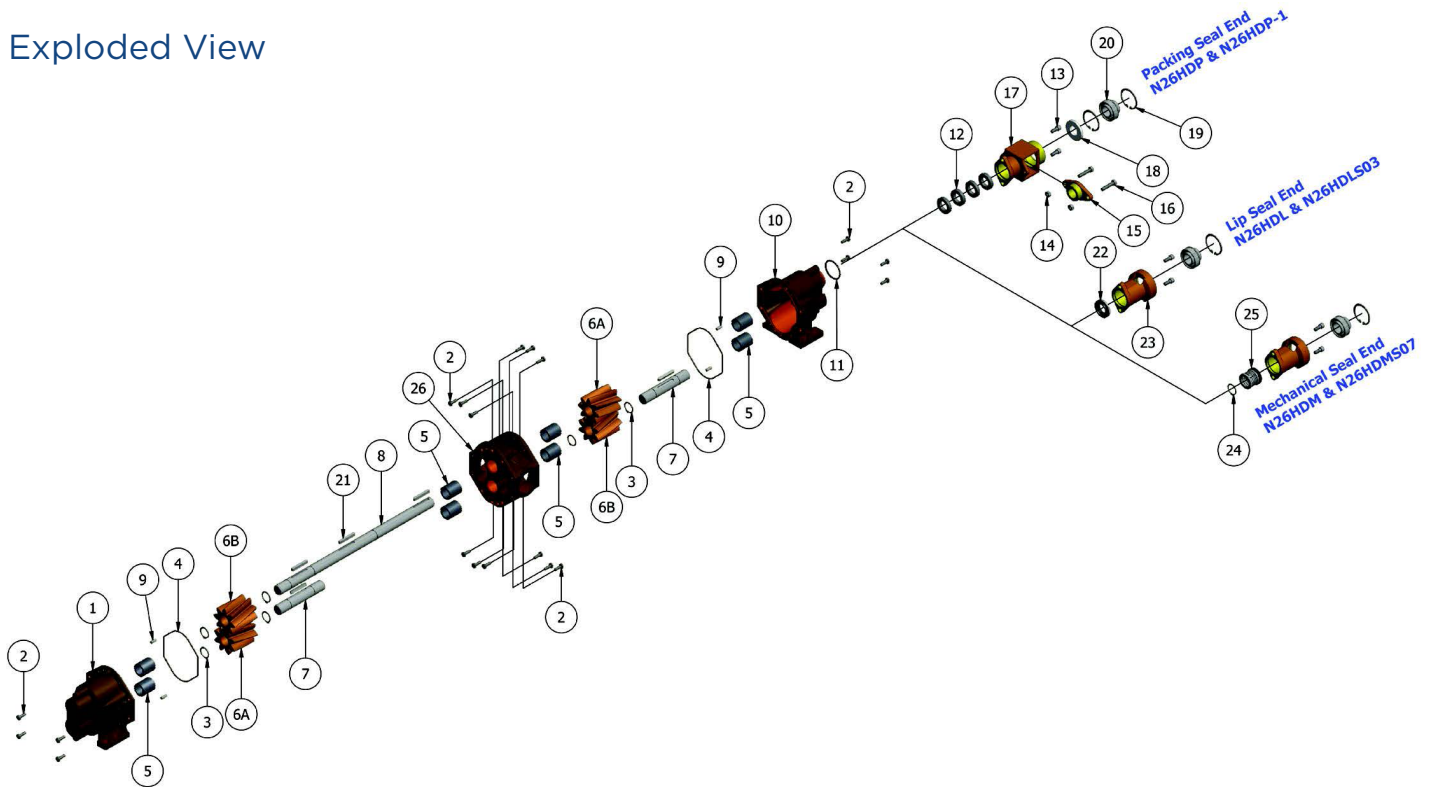
## Exploded View

1	2	3	4	5	6a	6b	7	8	9	10	11	12	13
	Body Rear	Screw	Snap Ring	O-Ring	Bearing	Drive Gear	Idle Gear	Idle Shaft	Drive Shaft	Dowel Pin	Body Front	O-Ring	Packing Ring	Screw
Model	Qty. 1	Qty. 20	Qty. 6	Qty. 2	Qty. 8	Qty. 2	Qty. 2	Qty. 2	Qty. 1	Qty. 4	Qty. 1	Qty. 1	Qty. 4	Qty. 2
OBN26HDPE	OB5220PN5N	OB5694	OB7651	OB9797-158	OB5108	OB9854	OB9855	OB7653	OB7571	OB8597	OB5220PN7N	OB6515	OB7624	OB6827
OBN26HDPE-1	OB5220PN5N	OB5694	OB7651	OB9797-158	OB5108	OB9854	OB9855	OB7653	OB7571	OB8597	OB5220PN7N	OB6515	OB7450	OB6827
OBN26HDLE	OB5220PN5N	OB5694	OB7651	OB9797-158	OB5108	OB9854	OB9855	OB7653	OB7571	OB8597	OB5220PN7N	OB9797-224	N/A	OB6827
OBN26HDLES3	OB5220PN5N	OB5694	OB7651	OB9797-158	OB5108	OB9854	OB9855	OB7653	OB7571	OB8597	OB5220PN7N	OB6515	N/A	OB6827
OBN26HDME	OB5220PN5N	OB5694	OB7651	OB9797-158	OB5108	OB9854	OB9855	OB7653	OB7571	OB8597	OB5220PN7N	OB6515	N/A	OB6827
OBN26HDMES7	OB5220PN5N	OB5694	OB7651	OB9797-158	OB5108	OB9854	OB9855	OB7653	OB7571	OB8597	OB5220PN7N	OB9797-224	N/A	OB6827

OBN26HDMES8	OB5220PN5N	OB5694	OB7651	OB9999-158	OB5108	OB9854	OB9855	OB7653	OB7571	OB8597	OB5220PN7N	OB6515	N/A	OB6827

14	15	16	17	18	19	20	21	22	23	24	25	26*	27	Repair Kit
	Nut	Gland	Screw	Seal Housing	Seal	Snap Ring	Ball Bearing	Key	Lip Seal	Seal Housing	Ring	Seal Assy	Tie Block	Tag	
Model	Qty. 2	Qty. 1	Qty. 2	Qty. 1	Qty. 1	Qty. 1 or 2	Qty. 1	Qty. 5	Qty. 1	Qty. 1	Qty. 1	Qty. 1	Qty. 1	Qty. 1	
OBN26HDPE	OB8395	OB7451	OB9905	OB7449	OB6710	OB7372 (2 Req'd)	OB7368	OB5975	N/A	N/A	N/A	N/A	OB2286	OB7737	OB11015
OBN26HDPE-1	OB8395	OB7451	OB9905	OB7449	OB6710	OB7372 (2 Req'd)	OB7368	OB5975	N/A	N/A	N/A	N/A	OB2286	OB7737	OB11016
OBN26HDLE	N/A	N/A	N/A	N/A	N/A	OB7372 (1 Req'd)	OB7368	OB5975	OB7262	OB7365	N/A	N/A	OB2286	OB7737	OB11017
OBN26HDLES3	N/A	N/A	N/A	N/A	N/A	OB7372 (1 Req'd)	OB7368	OB5975	OB6500	OB7365	N/A	N/A	OB2286	OB7737	OB11018
OBN26HDME	N/A	N/A	N/A	N/A	N/A	OB7372 (1 Req'd)	OB7368	OB5975	N/A	OB7365	OB7651	OB32315	OB2286	OB7737	OB11019
OBN26HDMES7	N/A	N/A	N/A	N/A	N/A	OB7372 (1 Req'd)	OB7368	OB5975	N/A	OB7365	OB7651	OB32372	OB2286	OB7737	OB11020

OBN26HDMES8	N/A	N/A	N/A	N/A	N/A	OB7372 (1 Req'd)	OB7368	OB5975	N/A	OB7365	OB7651	OB33335	OB2286	OB7737	TBD

Repair Kits contain items 3, 4, 5, 6, 7, 8, 11, 12, 18, 22, 24 & 25.  
Item 27 not depicted.

\* The sub-assembly part no. for the Tie Block with (4) OB5108 bearings (item 5) installed is OB32129.

**IMPORTANT:** Before attempting to remove a seal housing containing seal components by sliding them off the pump shaft, be sure to unlock 2 set screws locking the ball bearing inner race to the pump shaft. The ball bearing is identified as item 20. Also, before attempting to slide the seal housing from the pump shaft, remove all burrs, scale, and projections that could be formed by fretting corrosion.
